# AL572B Updates and Error Corrections

Rev0A 11/3/22 W&JI

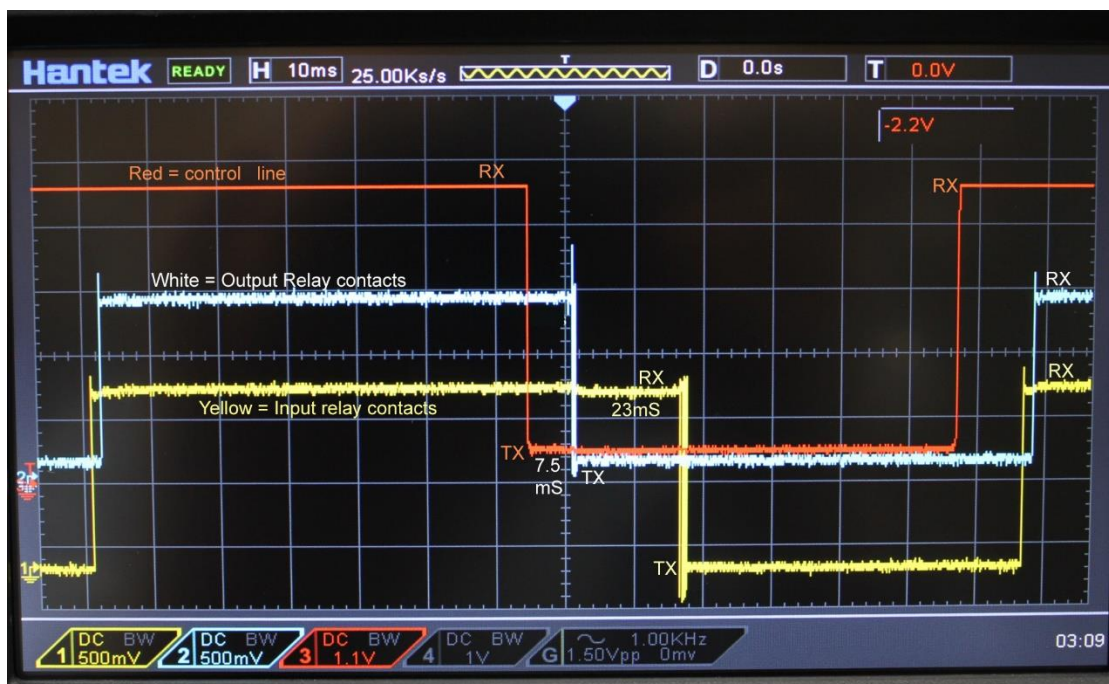
Figure 1 stock timing dual relay

At some point someone at MFJ modified the relay system to use two plastic case miniature cube relays. MFJ-modified systems using two relays have both relay timing and keying line impedance (sensitivity) problems. The small cube or enclosed DIP relays themselves switch and settle in 6mS or less. However, MFJ circuit design errors needlessly extend relay closure into the 20-30mS region. The system should actually be in the 6mS area. Making matters worse, the relay return-to-receive is very unreliable due to major relay control line impedance errors.

Factory circuit errors in all “AL8B frames” using small enclosed relays cause shortened relay life, unreliable receive return, and grossly excessive TX delay time requirements. The basic dual relay keying circuit design is very poorly planned, but a few simple patches will make it workable.

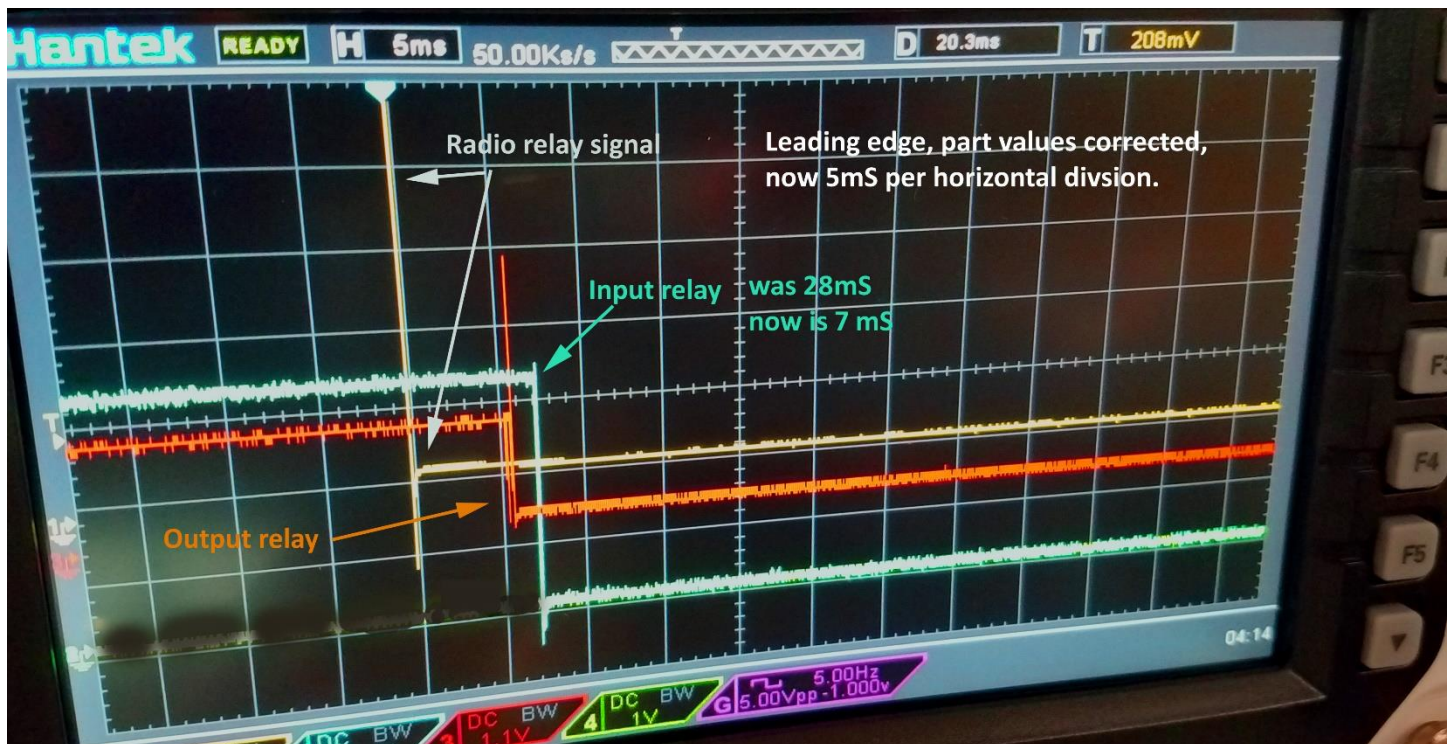
Figure 2 corrected relay timing

The switch to transmit time is the critical time that must be programmed into the radio. Unless the radio has a severe design defect this is the only window causing hot switching, and the only window of concern. This is the leading-edge (RX-to-TX) result of these changes (other issues not shown that improve relay life and receive recovery time are also corrected):

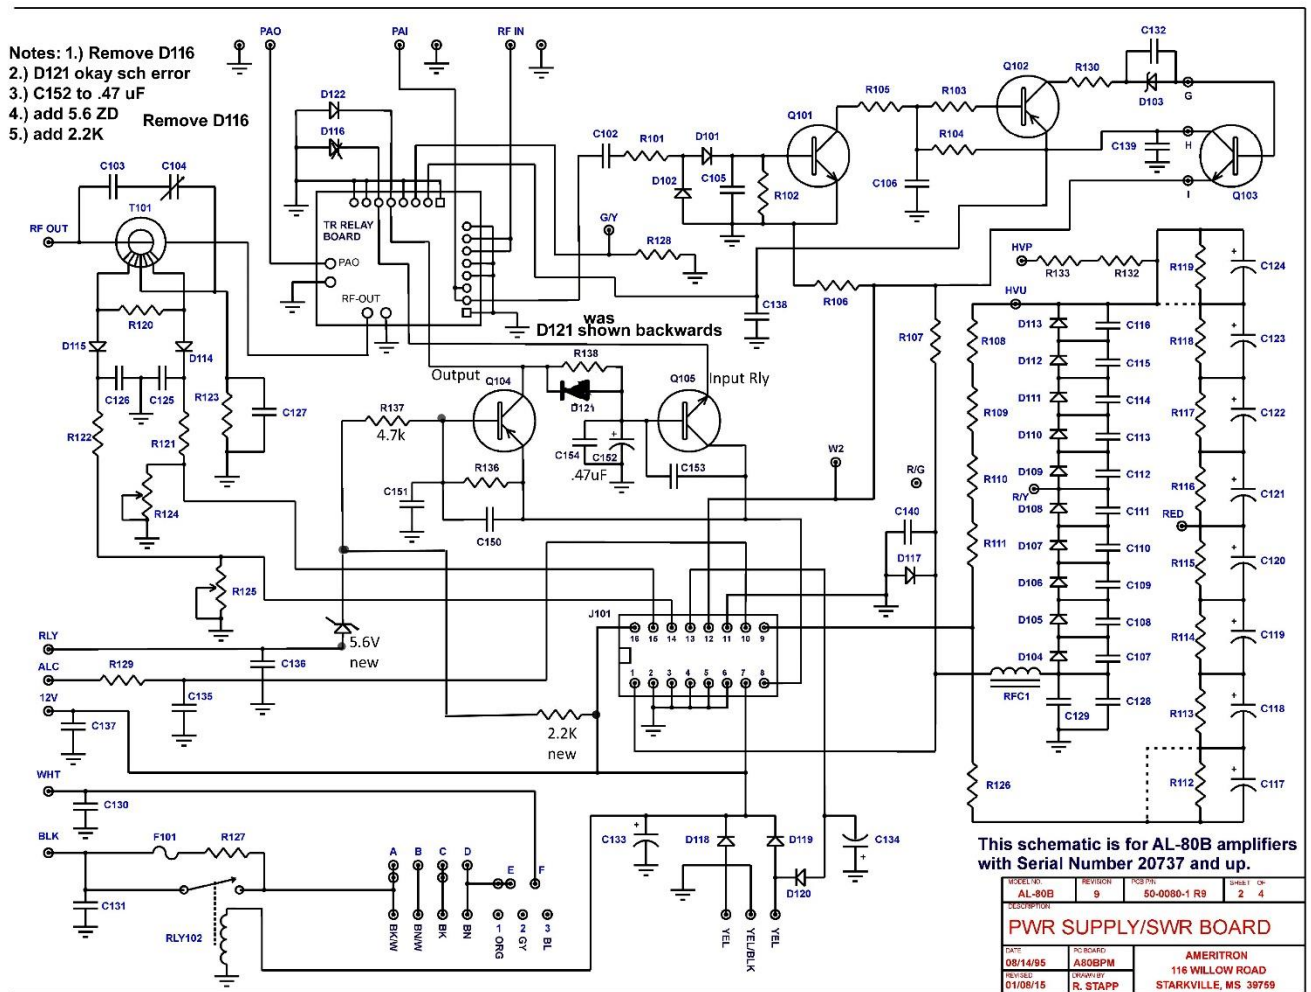
Figure 6 modified schematic

The reworked relay system now looks like this (note that D121 is drawn backwards in some or all MFJ schematics, although D121 is the correct direction as mounted in the circuit board):

The relay system with these simple mods is now about 6mS receive-to-transmit turn over time. Any exciter TX delay setting beyond 7mS will be more than enough.

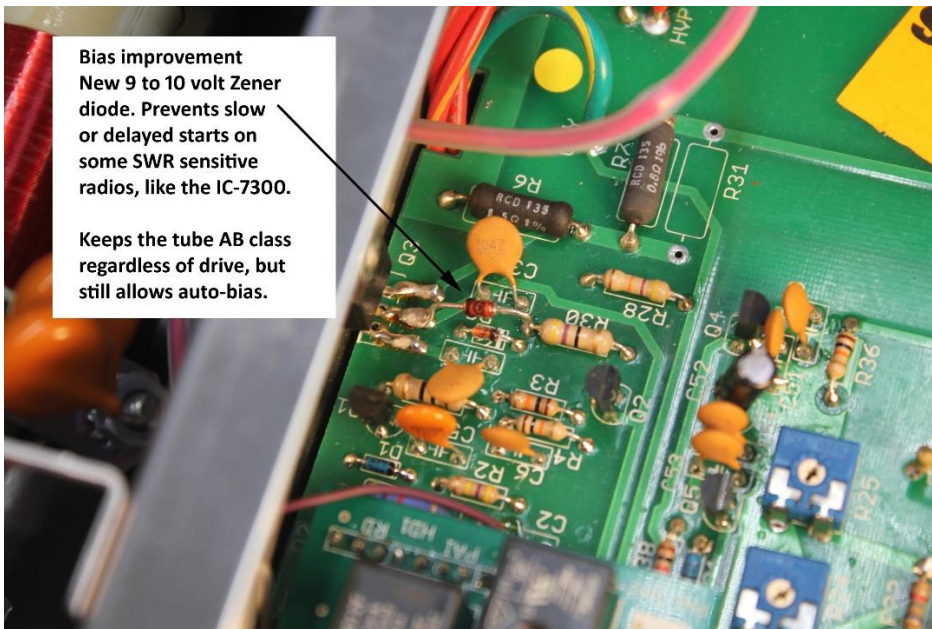
Figure 7 bias system mods

The electronic bias system in the AL8B frame amplifiers went through one authorized change very early in production. This change was relocating the sample point from the T/R relay tuned input contact to the output side of the tuned input. This was accomplished by adding a violet jumper wire directly from the input switch wafer to C102. I have never seen this corrected in schematics, but this correction must be made.

- 1.) Add 9.6V Zener diode from either side of R130 to collector (middle terminal) of Q103, banded end to Q103. The Zener can sit up in the air a little.

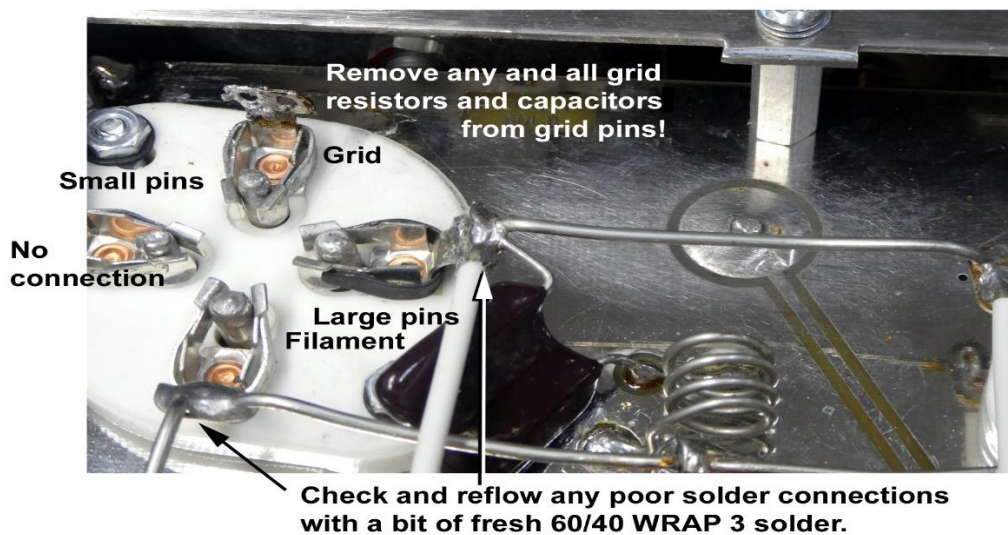
Figure 11 grid mods AL572

Grid pins of 572 tubes must be directly grounded and GDTs should be added to the filaments. This is easy to do because the tube chassis is a tinned circuit board without solder masking. You can solder directly to the ground plane of the board without any lugs. Follow these pictures and make sure you make good connections by using enough heat to flow solder.

2. Add foil, braiding, or at least #18 stranded wire directly from grid pin to printed circuit chassis ground plane.
3. Add two GDT's, one from each side of filament system anywhere convenient, to ground plane of board.
