AL80B AL572 AL800(H) Updates and Error Corrections

Rev2A 2/17/23 W8JI

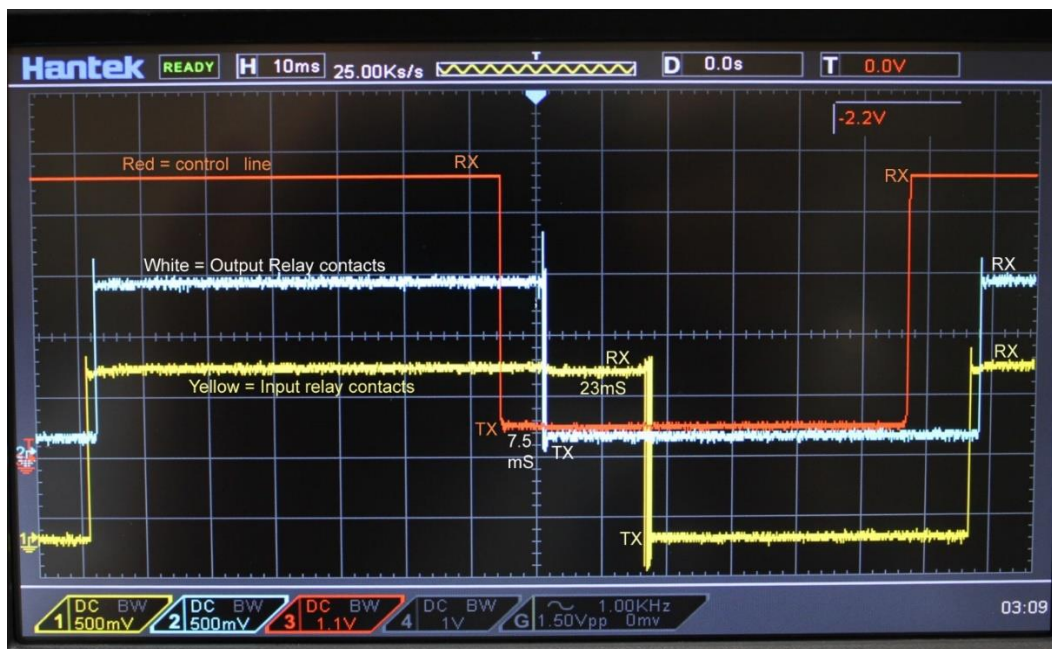
Figure 1 Stock timing

At some point, someone at MFJ modified the antenna relay system to use two plastic case miniature cube relays. MFJ-modified systems using two relays have major relay timing and keying line impedance (sensitivity) problems. The small cube or enclosed DIP relays themselves switch and settle in 6mS or less. However, MFJ circuit design errors needlessly extend relay closure into the 20-30mS region. The system should actually be in the 6mS area. Making matters worse, the relay return-to-receive is very unreliable due to major relay control line impedance errors.

Factory circuit errors in all “AL8B frames” using small enclosed relays cause shortened relay life, unreliable receive return, and grossly excessive TX delay time requirements. The basic dual relay keying circuit design is very poorly planned, but a few simple patches will make it workable.

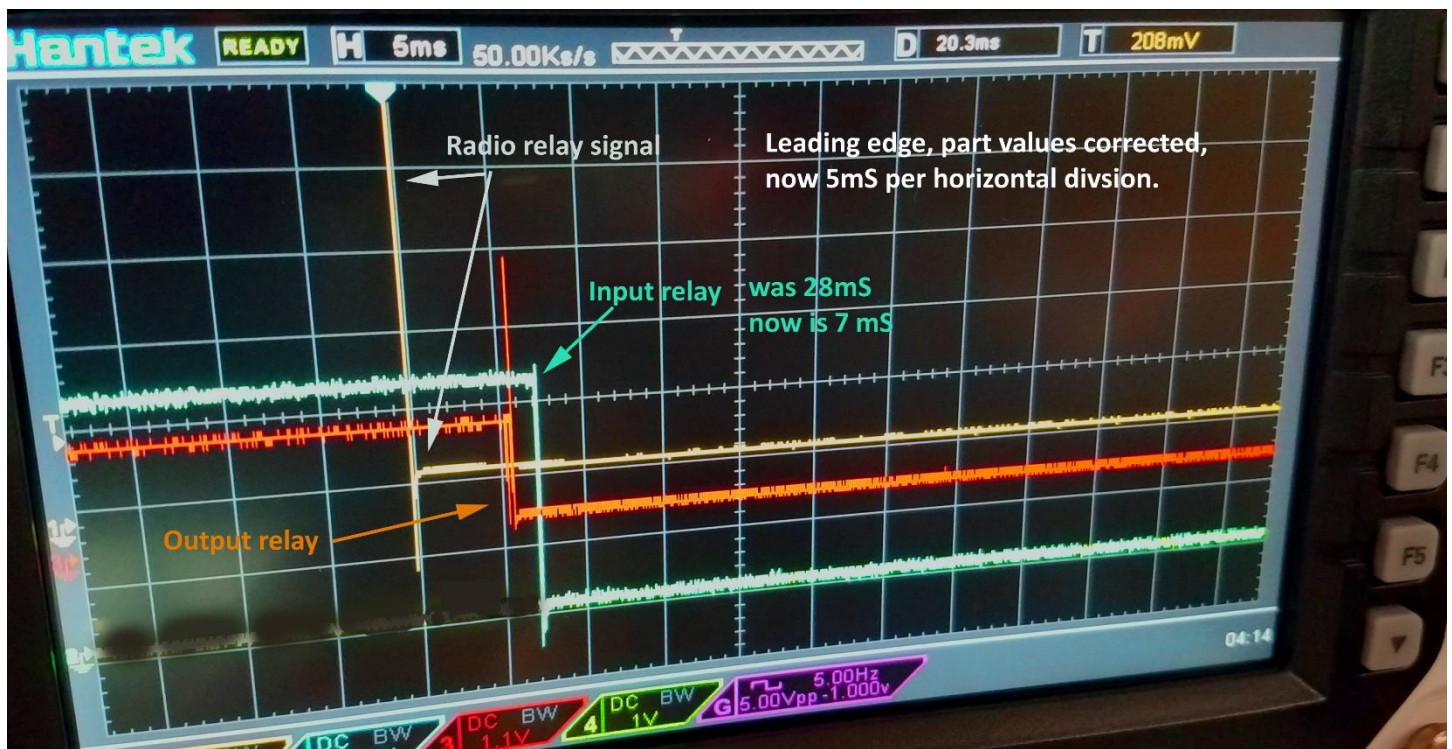
Figure 2 modified timing

The switch to transmit time is the critical time that must be programmed into the radio. Unless the radio has a severe design defect the receive-to-transmit window is the only switching window causing hot-switching and thus the only window of concern. Figure 2 is the leading-edge (RX-to-TX) result of these changes (other issues not shown that improve relay life and receive recovery time are also corrected):

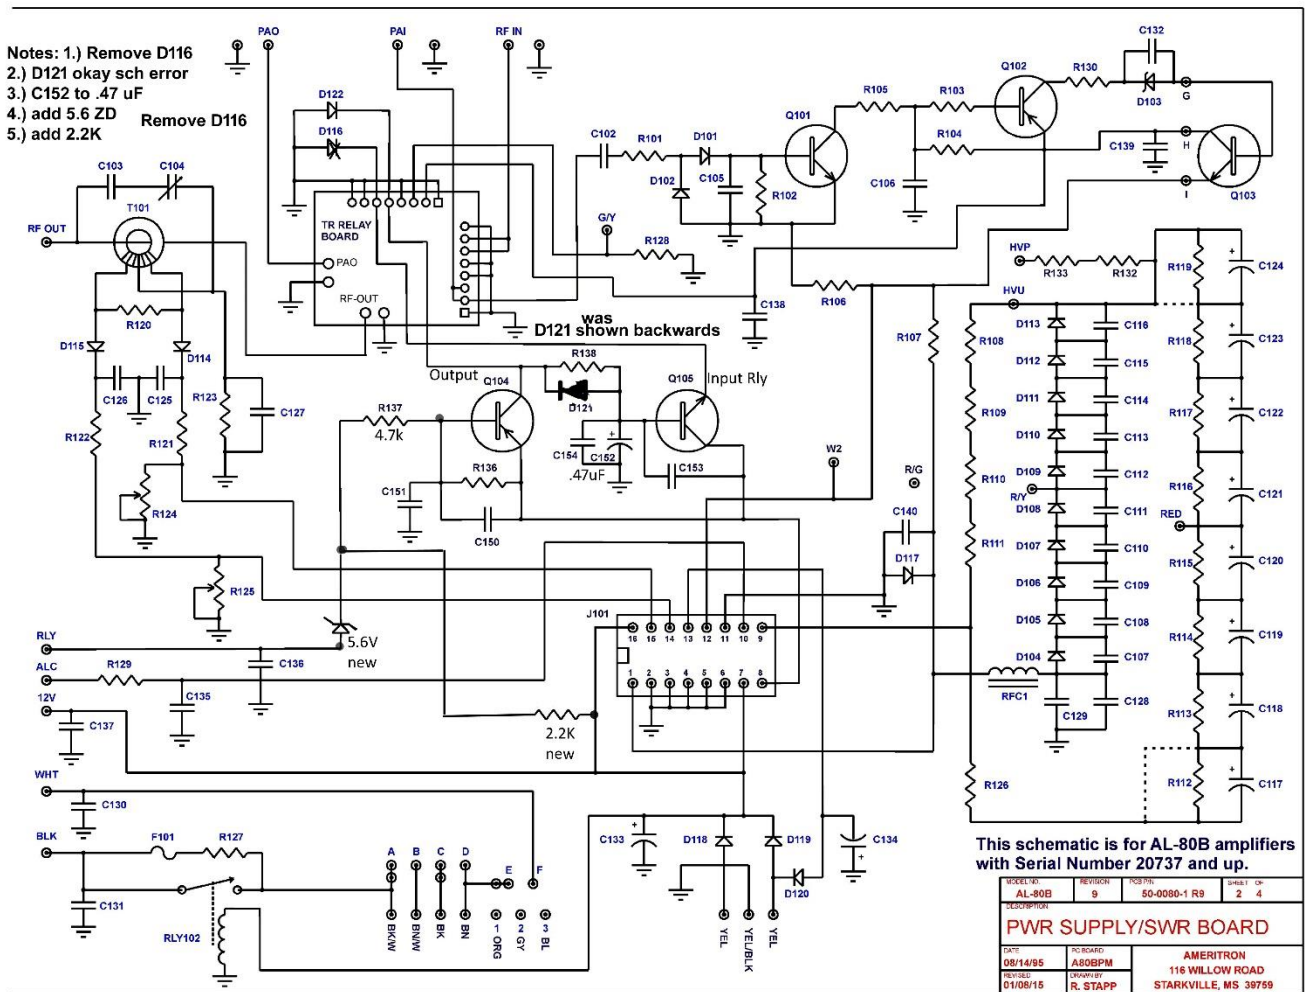
The reworked relay system now looks like this (note that D121 is drawn backward in some or all MFJ schematics, although D121 is usually installed in the correct direction as mounted in the circuit board):

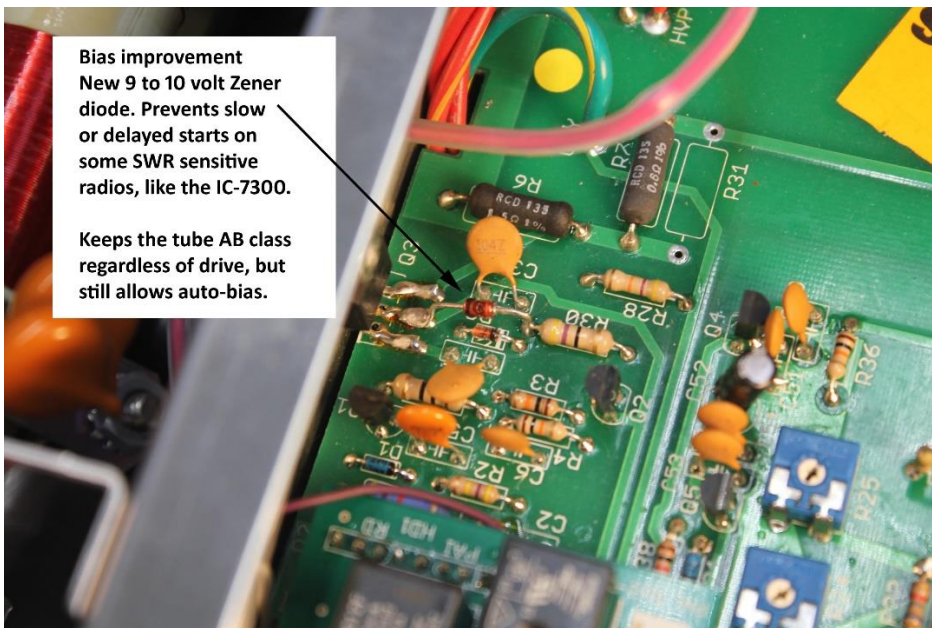
Figure 7 bias changes

The electronic bias system in the AL8B frame amplifiers went through one authorized change very early in production. This change was relocating the sample point from the T/R relay tuned input contact to the output side of the tuned input. This was accomplished by adding a violet jumper wire directly from the input switch wafer to C102. I have never seen this corrected in schematics, but this correction must be made.

- 1.) Add 9.6V Zener diode from either side of R130 to collector (middle terminal) of Q103, banded end to Q103. The Zener can sit up in the air a little.

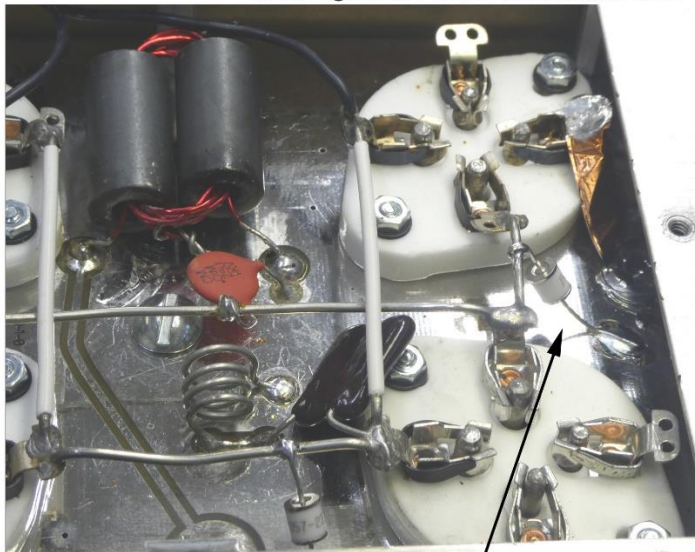
Early AL572 amplifiers had the control grids floated through equalizing resistors, much like the early AL811H. I initially bought into the equalizing resistor idea Collins started until I made measurements and analyzed performance. Additionally, we had field problems with amplifiers damaging radios. This problem is substantially aggravated by floating control grids off ground in triodes.

The first thing to do is to remove any resistors and bypass capacitors and directly ground the grids with the supplied braiding.

Ground each grid pin to the circuit board with a short length of copper foil, braiding, or #14-18 AWG stranded wire

Add GDT from each filament side to backplane foil.

The second thing to do is add GDTs (gas discharge tubes) from each side of the filament to ground.

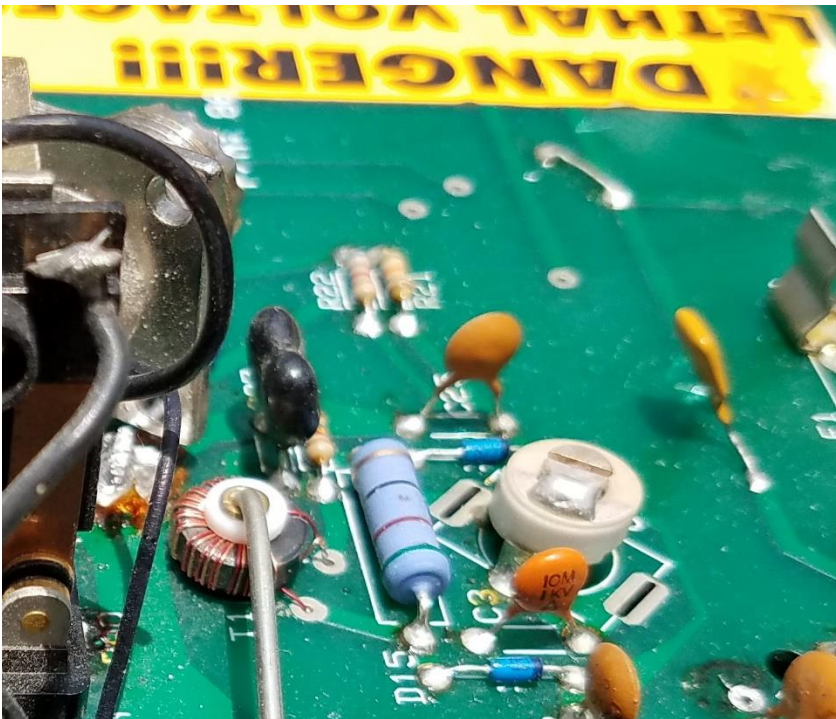
Figure 16 Incorrect transformer

I recently discovered that years ago, despite conversations, emails, and documents to MFJ in the design stages, a layout person changed the main circuit board in the current transformer area. The problem is someone made the shield eyelet hot with RF. The brass eyelet was always supposed to just fit inside the pickup coil and be grounded. The RF was supposed to pass through the eyelet using a Teflon insulated wire. This error is all units in the AL8X frame, including the AL800, AL800H, AL572, and AL80B units

The symptom is forward and reflected bridge diode failures or destruction of the PC board and transformer.

The brass eyelet in the toroid center was supposed to be a grounded electrostatic shield. This makes directional coupler performance better while also isolating the diodes and transformer from damaging static discharges and/or transients from arcs in antenna tuners and feedlines.

Someone at MFJ negated all that by making the eyelet hot, common with the center conductor. Compounding this error, MFJ sometimes uses cheap regular plastic or nylon insulators to isolate the electrically hot eyelet from the pick-up coil instead of Teflon. Even a Teflon bushing is not a good cure, and nylon is much worse.

I have not found a simple fix yet for this error, other than removing the feed wire and eyelet, gluing the transformer down with RTV, and passing a Teflon insulated wire through the transformer. This unfortunately is the most difficult factory error to correct.
