AL80B (AL800, AL800H) AL572B Mods and Changes

W8JI rev1e Mar18, 2024

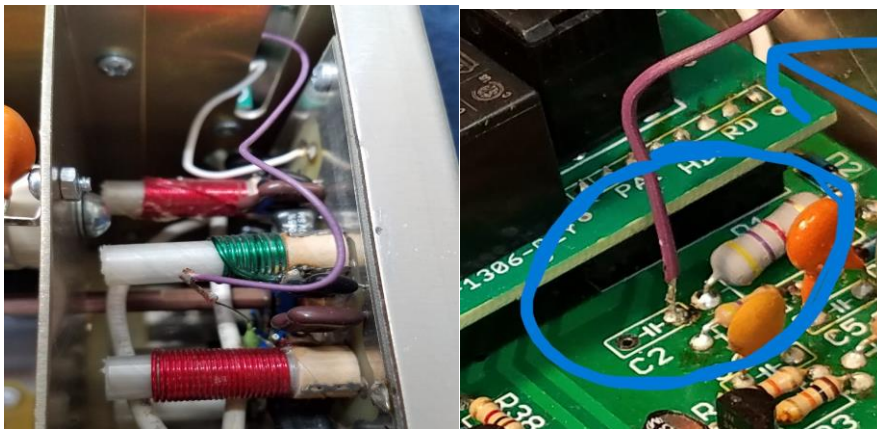
Figure 1 Violet wire EBS Tap Point

There was one very early change in the bias system. The RF sample pick point was moved to the output of the input circuit (tube side of the input). The early tap point at the relay caused threshold-level problems with some radios and some amplifier-to-radio cable lengths. This early correction removed the EBS sample point from the antenna relay. The tap was moved to the tuned input switch tube side. It traditionally uses a violet wire and relocates C3 from the power

(This early 1990s violet wire change has never been corrected on circuit boards or in the schematic.)

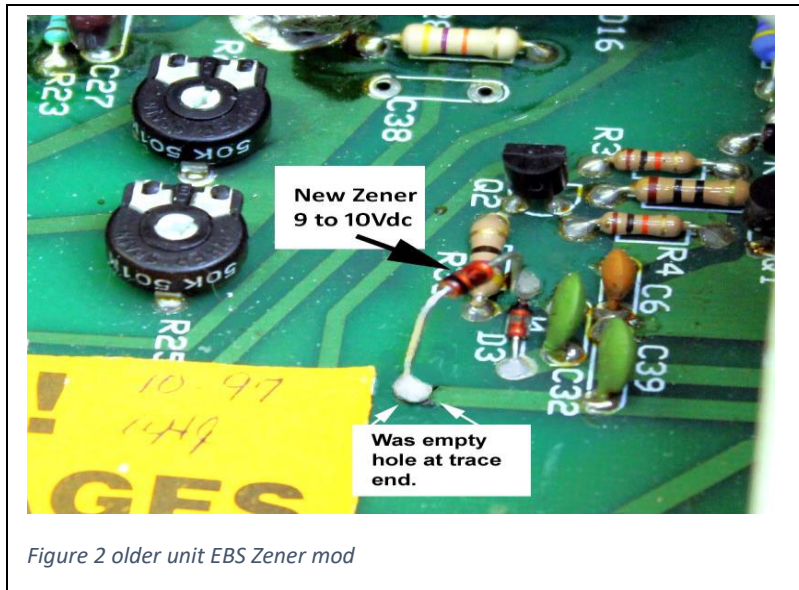
Figure 2 older unit EBS Zener mod

The AL80B only needs one EBS system update. Sometimes audio momentarily clips when the amplifier auto-bias is coming out of the cut-off state. Adding the 1N4739A 9.1V 1-watt Zener supplied in the AL8X kit corrects this issue.

In older open-frame relay units the kit Zener installs as shown with the black-banded diode end toward the empty hole at the end of the trace from the large black transistor on the center panel. The other end of the diode sweat solders to the junction of R30, D3 band end, and C32 far end. R30, D3, and C32 are a common connection point for the unbanded diode lead.

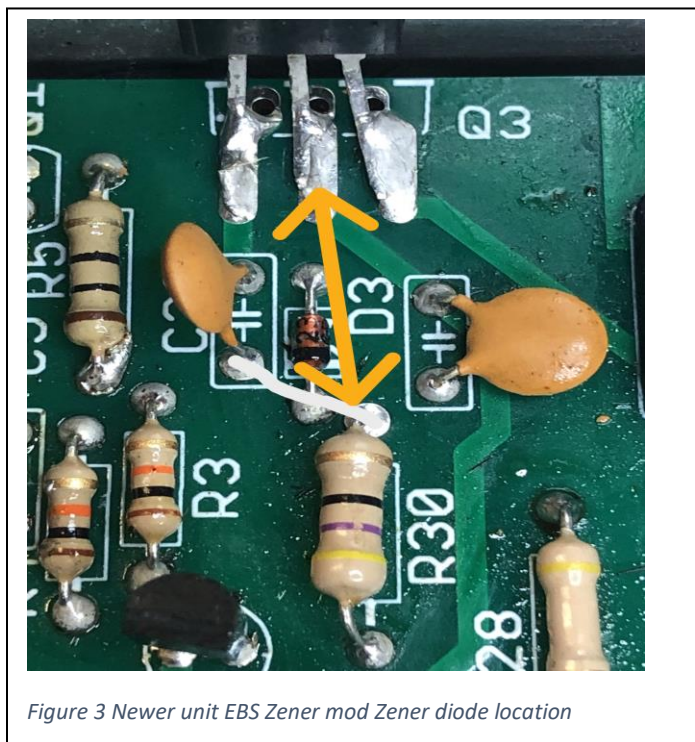
Newer units lack the empty hole in this trace. Later circuit boards with cube (enclosed) relays need the bias Zener installed differently. This is the same electrical circuit position, just a physical location change. In newer units, the Zener fits where this orange arrow shows. Figure 3 Newer unit EBS Zener mod

With newer units, pre-form the $\sim 9\text{V}$ Zener as shown (note: the exact voltage is not critical). Cut the leads each about $\frac{3}{4}$ inch or so long before bending. Just be sure the diode will fit the final position before snipping! Figure 3 Newer unit EBS Zener mod

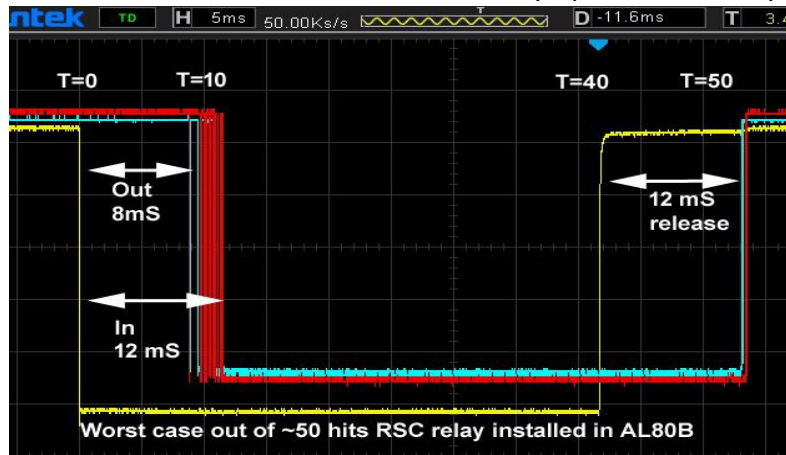
Figure 6 Relay timing early open-frame RSC relay

Note: The early open frame relay boards **do not** have relay keying voltage and speed issues. The early amplifier relays switch in time <13 mS and have normal current. Early open-frame relay amplifiers do not need antenna relay system corrections.

Early production amplifiers used larger open-frame relays. The early relays have a 13 mS or faster transfer time. Keep this in mind when setting TX delay times. 15mS is plenty of TX delay in radios like the IC-7300. Here is an early open-frame relay in the early AL8X series:

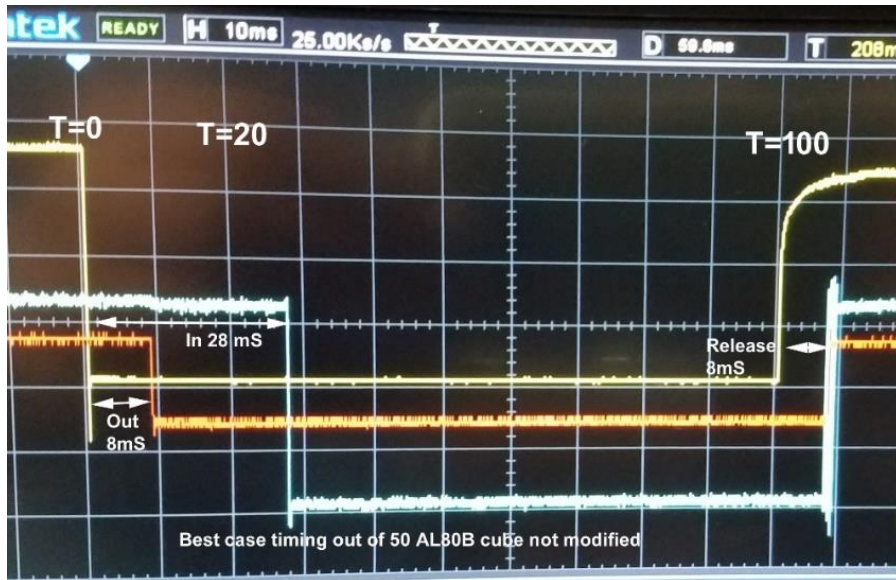
1. The keying line state threshold is too low, a drop of only 0.6 volts from open circuit voltage partly enables the relay system
2. The keying line impedance is too high, even 100k ohms leakage affects the relay system
3. A relay timing problem, the input relay is delayed far too long

These errors cause slow switching times and shorten relay life. They also make receiving through the amplifier less reliable. A timing measurement is shown in Figure 7 unmodified cube-relay amplifier timing

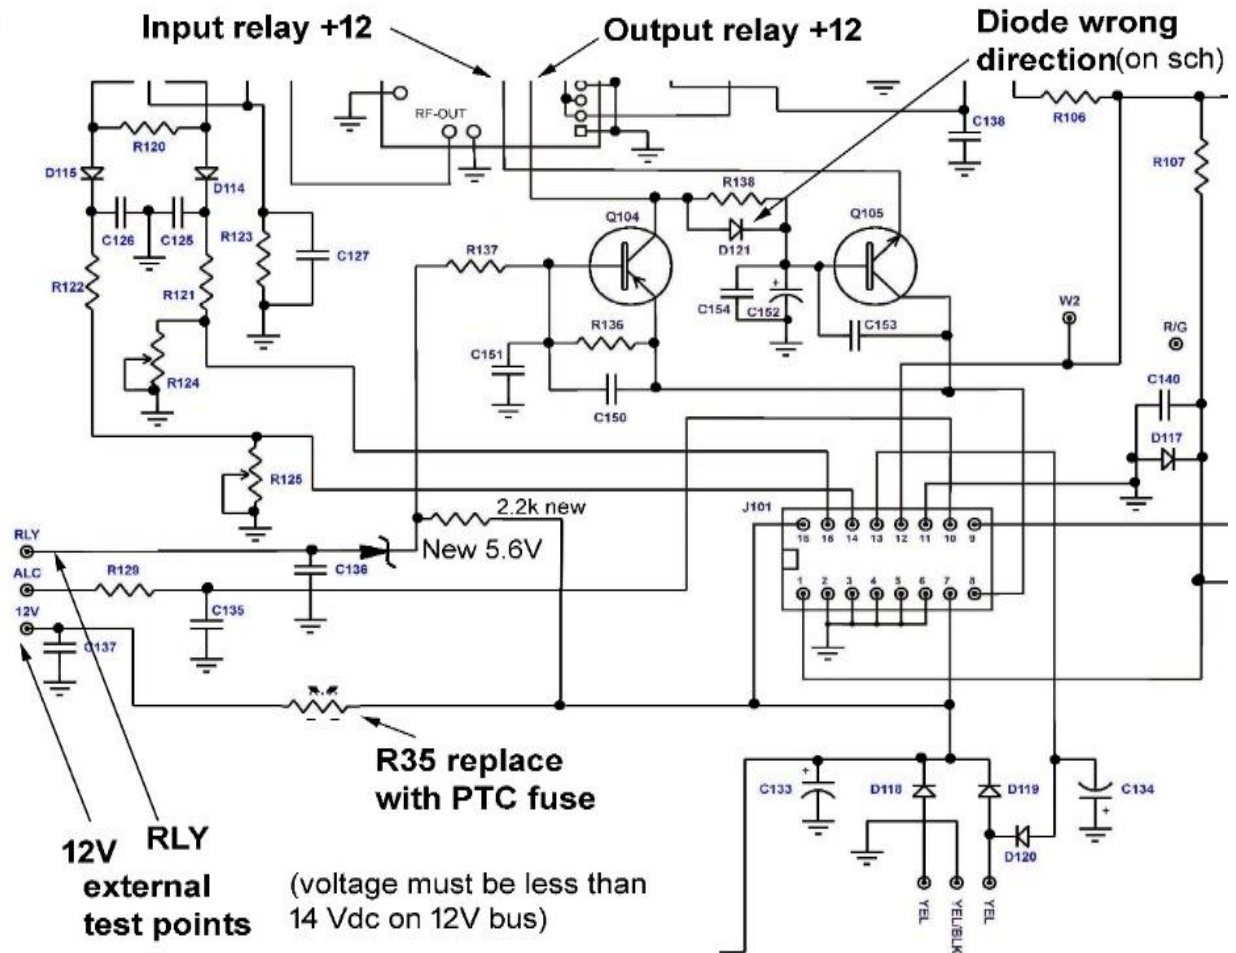
Figure 9 Relay area schematic

volts. This modified system is well within the range of virtually any radio. It makes the keying line less sensitive to capacitance, RF, or leakage resistances. (Diode D121 is shown backward on the schematic.)

The original 4.7k resistor R37 is lifted on the end shown. A Zener and 2.2K pull-up resistor are added. This modification creates a much lower source impedance via the new 2.2K resistor. The ~5-volt Zener greatly increases the threshold. The source current goes from a fraction of a milliampere to about 4 mA with a threshold voltage of about 5-6 volts instead of less than .7

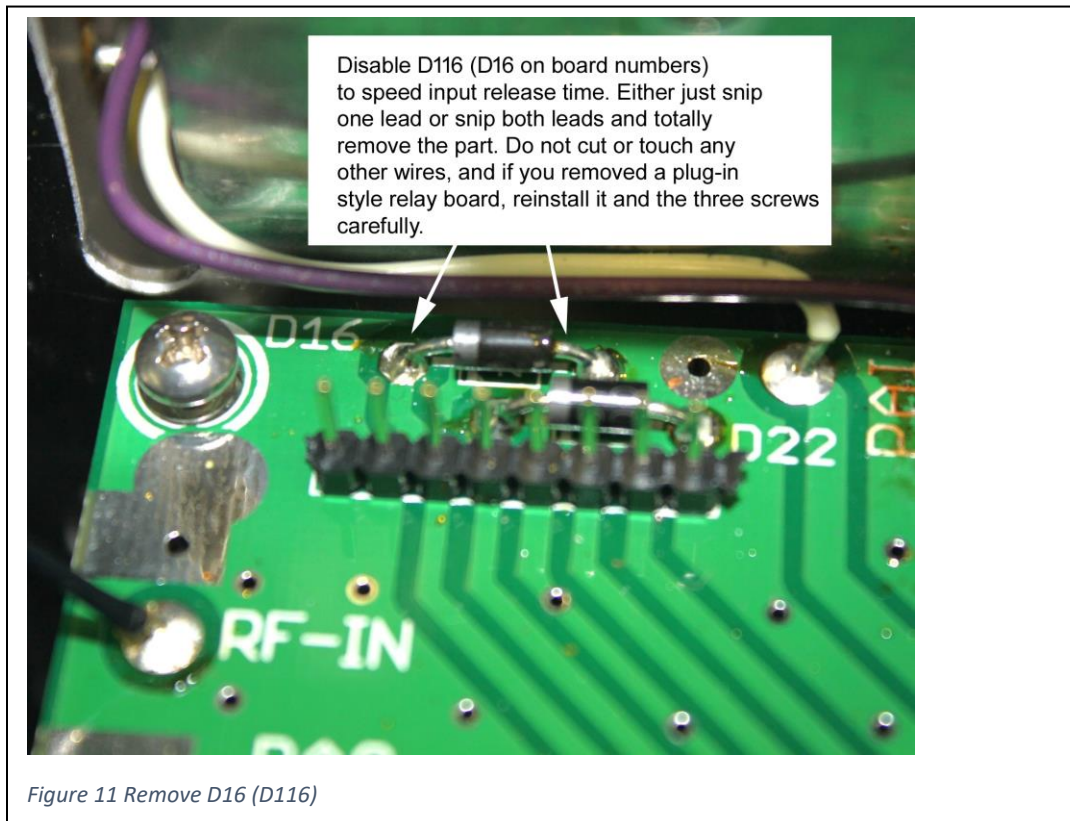
These mods make the internal relay switching time about 7 mS as opposed to 25-35 mS.

C152 is replaced with the kit's small .33 to .47 uF capacitor. The kit capacitor is not sensitive to direction.

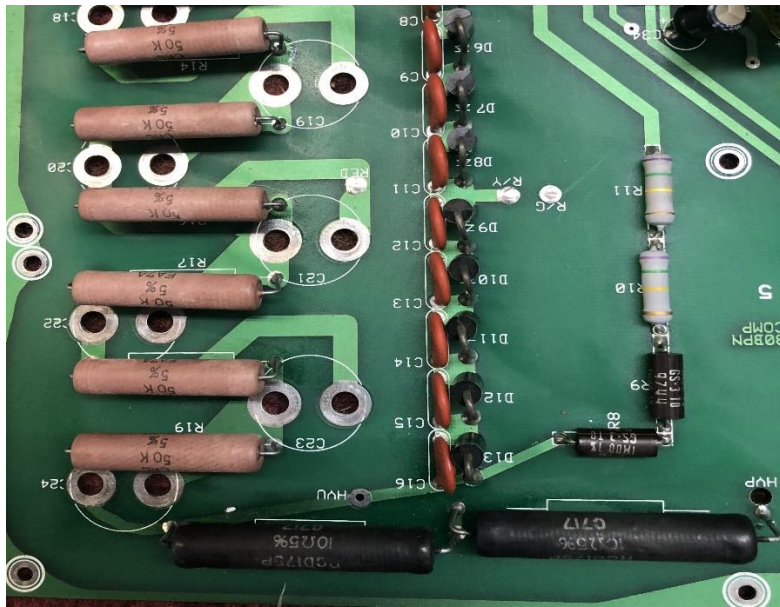
Figure 12 Pink Bleeders and fault resistors

Warning! If your amplifier has pink colored bleeder resistors, they should be replaced. The pink resistors were pulled from production because of high failure rates. When a resistor fails, it damages all filter capacitors in the bank. MFJ, when they ran out of good resistors, started using the bad resistors again. This means any year might have the old defective resistors. If you need these resistors we can supply reliable substitutes. Regardless of the replacement source, you must change the 50K 7-watt pink-color bleeder resistors.

The high-voltage power supply in the AL8X series (AL572, AL80B, AL800) is pretty reliable. The only common problem spots in the HV supply area are units with pink or light tan colored 50K 7-watt bleeder resistors. We have a policy of changing the pink or tan resistors shown in Figure 11. Any good quality 7-watt 50k-75K ohm resistor can be used to replace the troublesome resistors.

The two black 10-ohm fault limiting resistors at the bottom of Figure 12 are an excellent idea. If you need the replacement bleeders or the 10-ohm parts let us know.

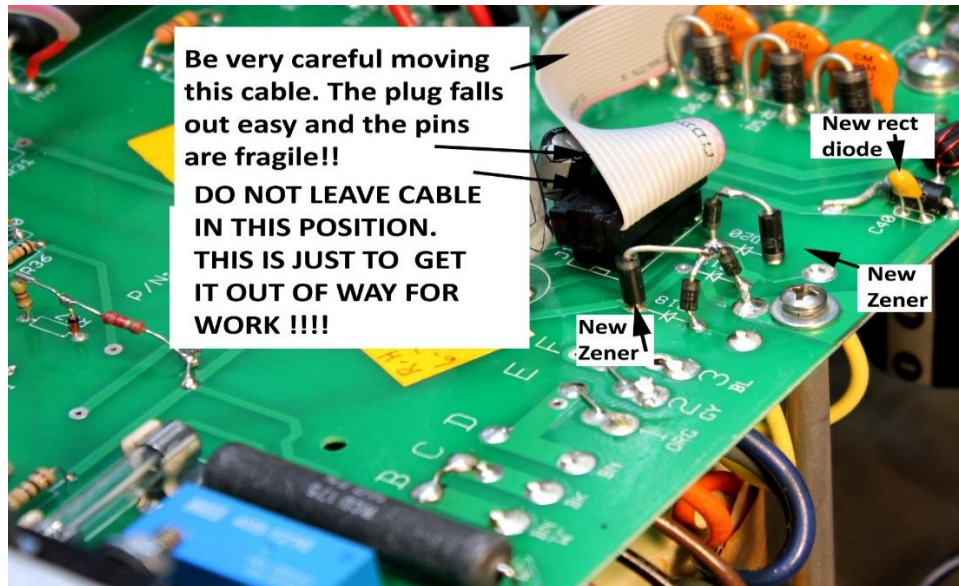
Figure 13 New Zener buck diode in severe 12V supply cases installed as shown.

Some transformers, I have no data on exactly how many, are incorrectly wound. The safe way to determine incorrect transformer voltages is by measuring the 12VDC rear panel jack center pin to the amplifier chassis or rear panel. This amplifier must have a minimum of 13 volts and a maximum of 15 volts on the rear panel 12VDC jack. The ideal target is 13.5-14 Vdc. The absolute maximum is 16 volts. Voltage above 16Vdc places one of the ALC op-amps and other components over maximum voltage ratings. This can lead to component failure. Going too low on voltage will excessively slow the T/R relay.

The op-amp that goes over-voltage runs on a differential between the negative and positive supplies and is rated at 32 Vdc differential. At 16 Vdc on each supply, the op-amp is right at 32 Vdc. Reducing the negative supply to -10 to -12 volts will be enough to save that op-amp.

Voltage can be reduced by patching in bucking Zener diodes at the low-voltage rectifiers. Our kit has two 1N5335B 3.9Vdc Zener diodes. If the voltage is over 17 Vdc, install a supplied 3.9V 1N5335B Zener diode in the negative and positive system as shown. Be sure the 12V line, as

tested at the rear jack, does not go below 13.5 Vdc. If the voltage is 14-16Vdc, just install one Zener in the negative single rectifier. You can leave the dual diodes on the positive side alone.

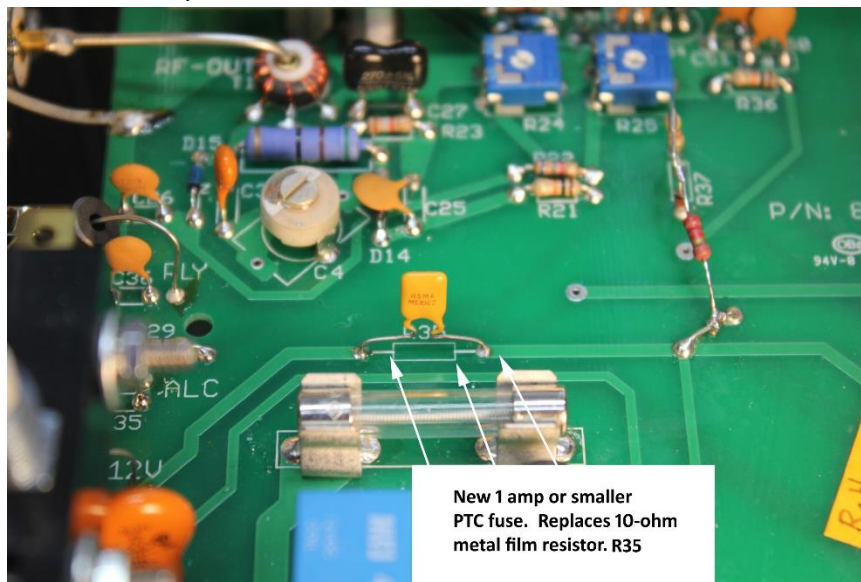
Figure 14

R135 (R35 on board) should be a 10-ohm ¼-watt film-type resistor (ideally metal) used as a fuse. The 12V jack is low current, provided for external “power on” or external accessory lights or metering in antenna tuners. To prevent damage if the 12V jack is overloaded or shorted, R35 was added. R35 limits short current to 1.5 amps until the resistor opens.

R35 can be replaced with a PTC auto-resettable fuse included in this kit.

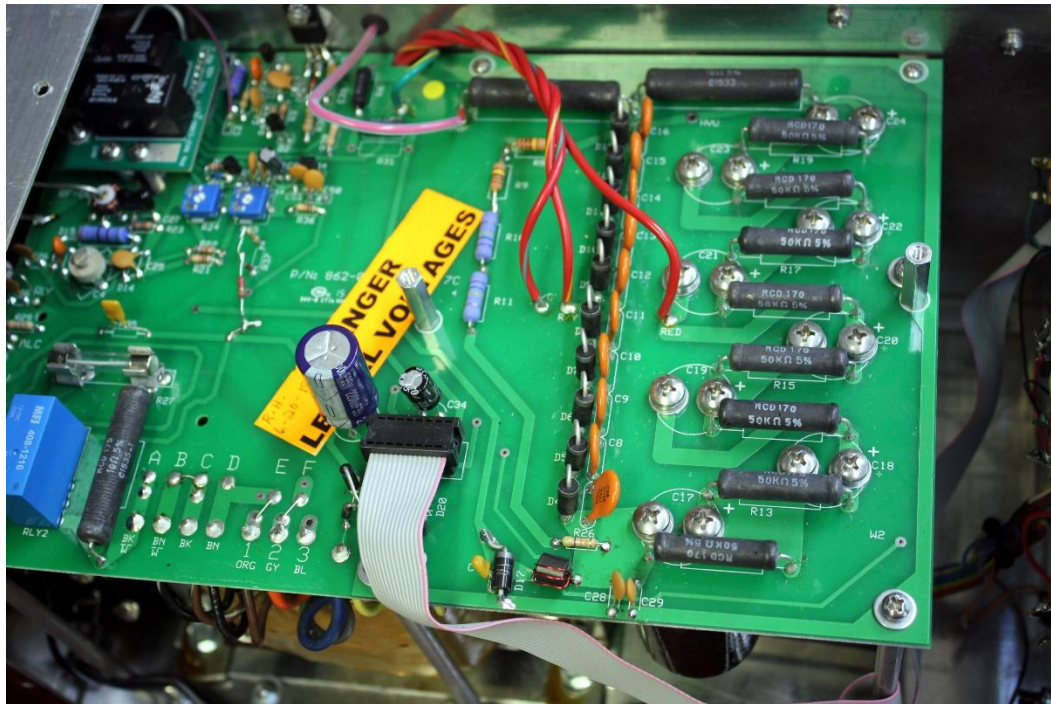
Figure 16 properly updated unit

This is the final ribbon cable location!!!

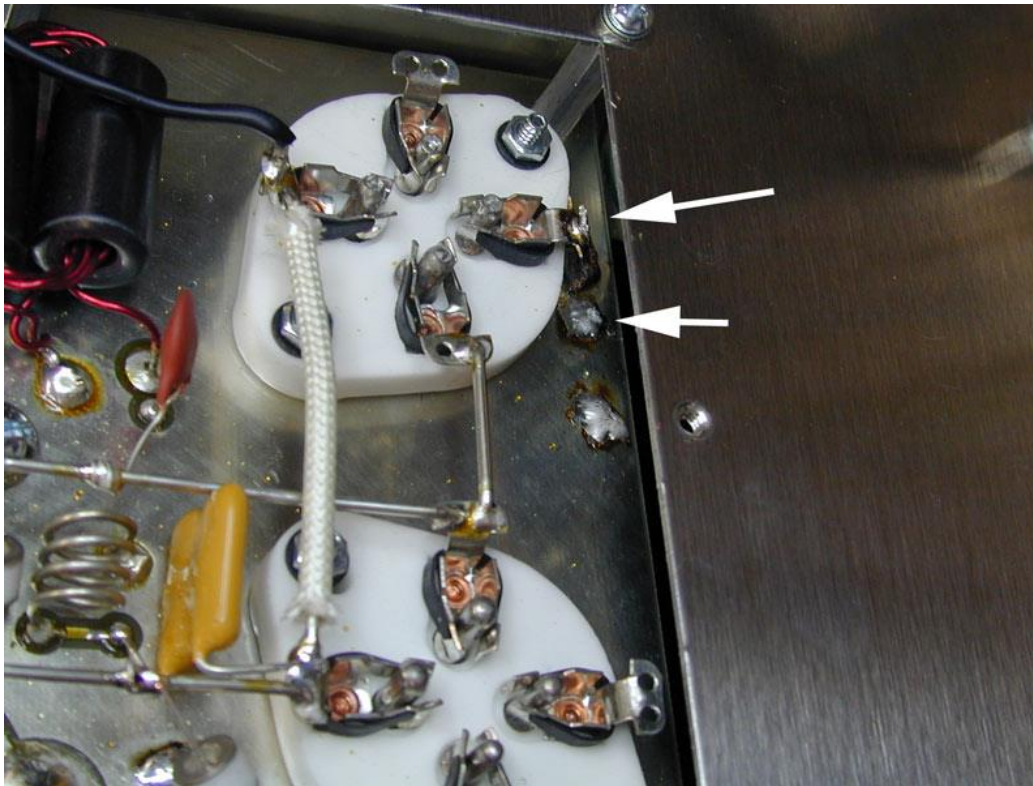
Figure 17 Ground 572B control grid pins

Early AL572 amplifier had control grid floating. We include braiding to ground the grids. Hopefully your amplifier will have a removable chassis bottom plate below the tubes.

Remove that plate and remove the four resistors and the orange .01 uF 1kV disk capacitors that go from the control grid pins to the printed circuit board that is used as a tube chassis. The braid can be soldered directly to that silver board.

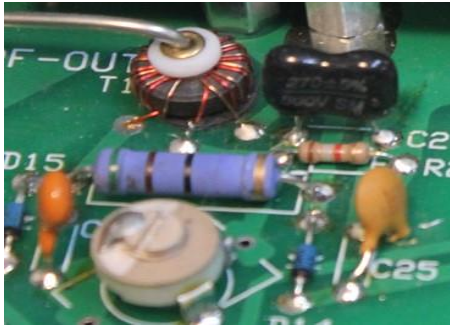
Figure 19 Good transformer insulator

A patch for this error was changing the center insulator from plastic to a white Teflon. A good transformer has a pure white Teflon center insulator in the toroid.

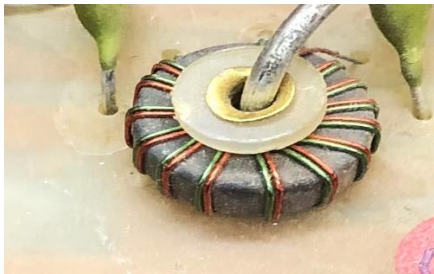
Figure 20 unreliable insulator

A translucent plastic insulator will occasionally arc, damaging the bridge diodes.

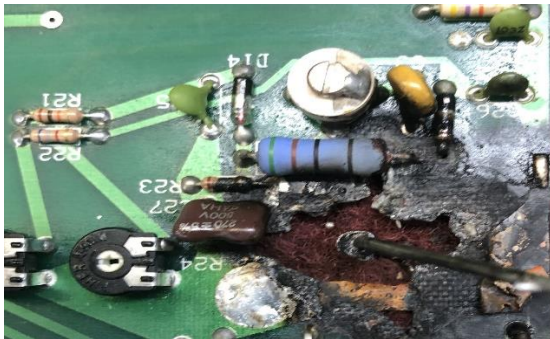
Figure 21 damaged board

In severe cases the wrong insulator will cause the circuit board to carbon track and fail:

We now have a replacement bridge for chronic diode or carbon-track board failures.
