# AL572B Updates and Error Corrections

Rev0A 11/3/22 W&JI

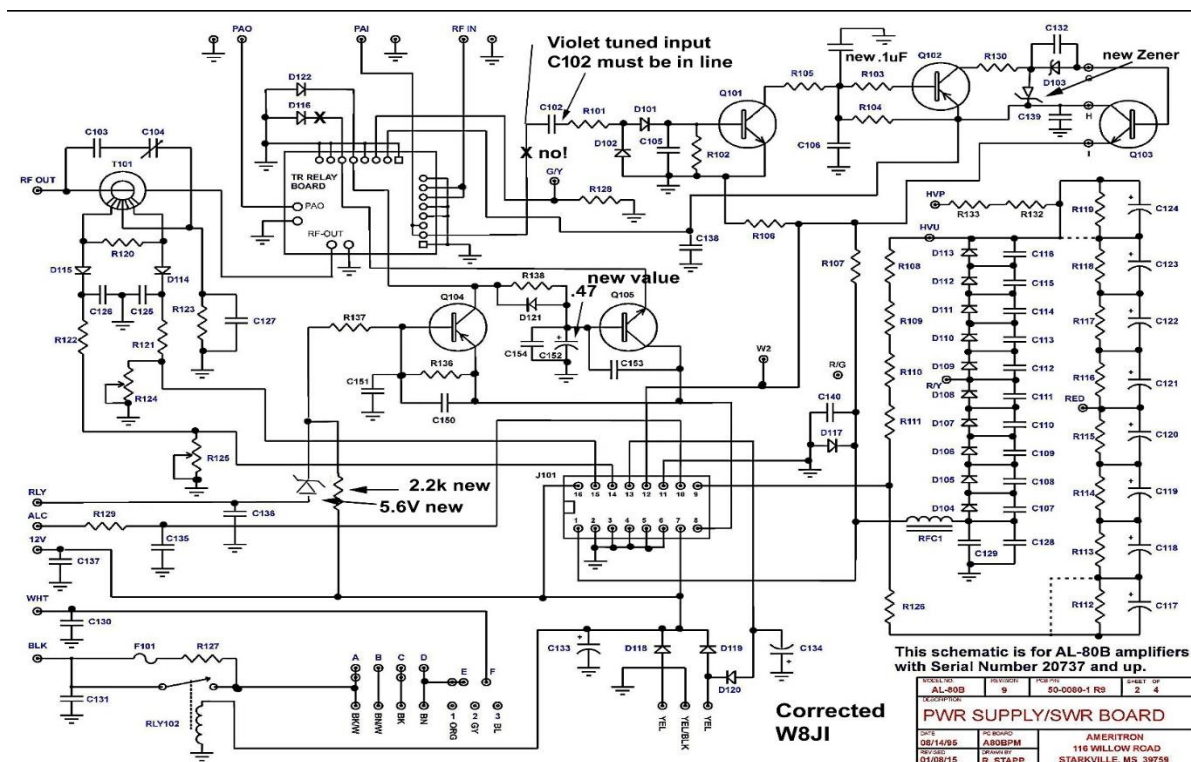
Figure 9 PS schematic corrected

The 12V bus system originally used a 21Vac CT transformer winding. Something happened over time and some A8X frames, including the AL80B, AL800, AL800H, and AL572, now might have grossly excessive bus voltages. The bus rails are both dc negative and positive, and these dual polarity rails feed a metering/ALC op-amp rated at 30-32Vdc maximum supply differential. Depending on the op-amp used and the rail voltages, the op-amp can fail and stop providing power meter and ALC functions.

The AL8X frame amplifiers were designed to have a 13 to 14 Vdc nominal 12V bus voltage. The positive bus appears at the rear 12V jack. Either a small trace link is used on the board, or a 10-ohm ¼-watt metal film resistor is used for short circuit protection. We replace those with a 900mA thermal reset PTC thermistor for fusing.

If your amplifier has a 10-ohm resistor or a fuse link they can be replaced with a thermal auto reset fuse. We included one auto reset fuse in the kit. We can also supply bucking diodes.
