AL80B AL572 AL800(H) Updates and Error Corrections

Rev2A 2/17/23 W8JI

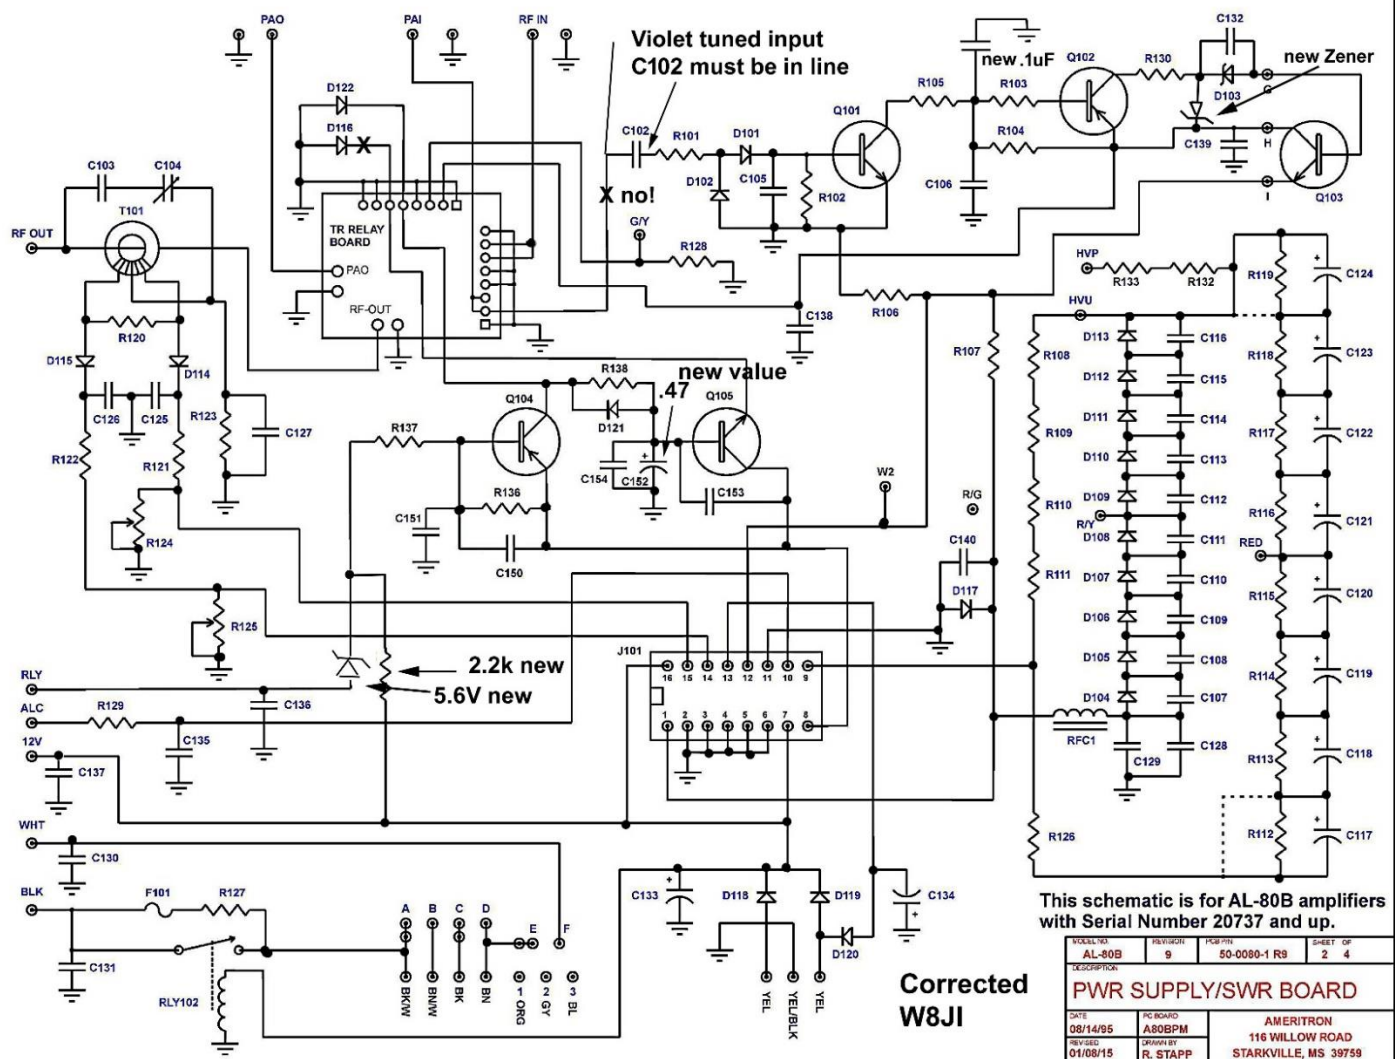
Figure 9 Corrected PS Schematic All Mods

The 12V bus system originally used a 21Vac CT transformer winding. Something happened over time and some A8X frames, including the AL80B, AL800, AL800H, and AL572, now might have grossly excessive bus voltages. The bus rails are both dc negative and positive, and these dual polarity rails feed a metering/ALC op-amp rated at 30-32Vdc maximum supply differential. Depending on the op-amp used and the rail voltages, the op-amp can fail and stop providing power meter and ALC functions.

I strongly suggest using bucking diodes or dropping diodes to get voltage to rated voltages if the positive bus exceeds 15Vdc.

If your amplifier has a 10-ohm resistor or a fuse link they can be replaced with a thermal auto reset fuse. We included one auto reset fuse in the kit. We can also supply bucking diodes.

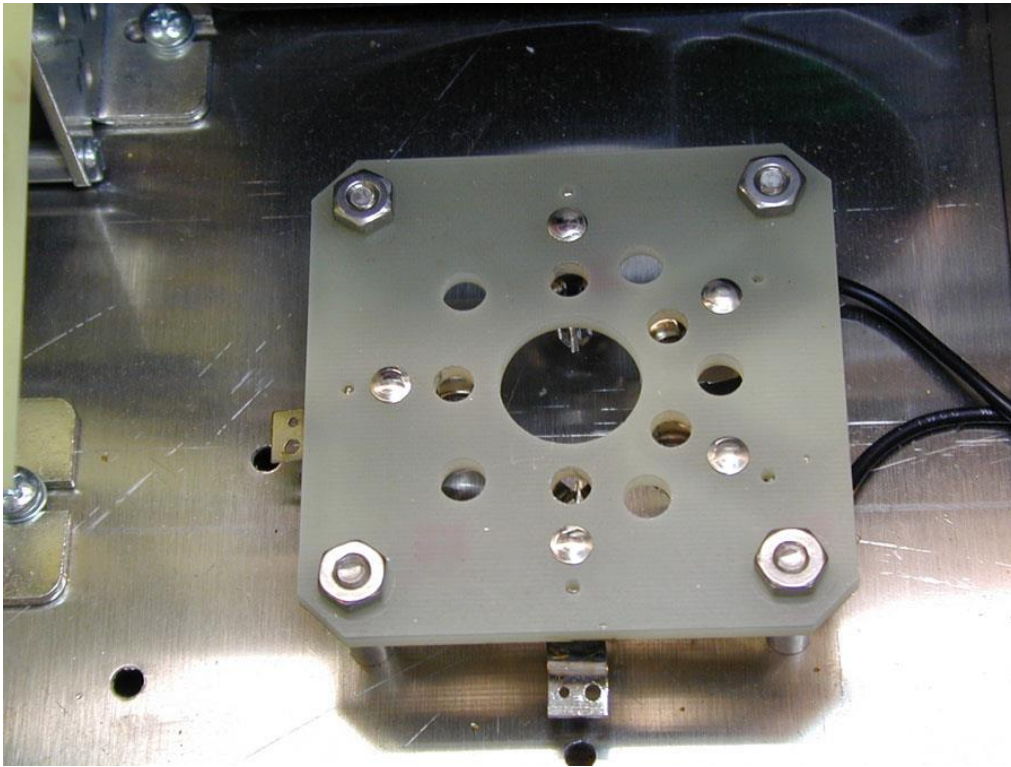
Figure 10 remove top nuts

Grid pins of 572 tubes (AL572 amplifier) must be directly grounded and GDTs should be added to the filaments. This is easy to do because the tube chassis is a tinned circuit board without solder masking. You can solder directly to the board's ground plane without any lugs. Follow these pictures and make sure you make good connections by using enough heat to flow the solder.

1. Remove the top nuts to flip the socket over
