# Arc Protection SB-200 Heathkit 30L-1 Collins

10 May 2023 W8JI Rev2

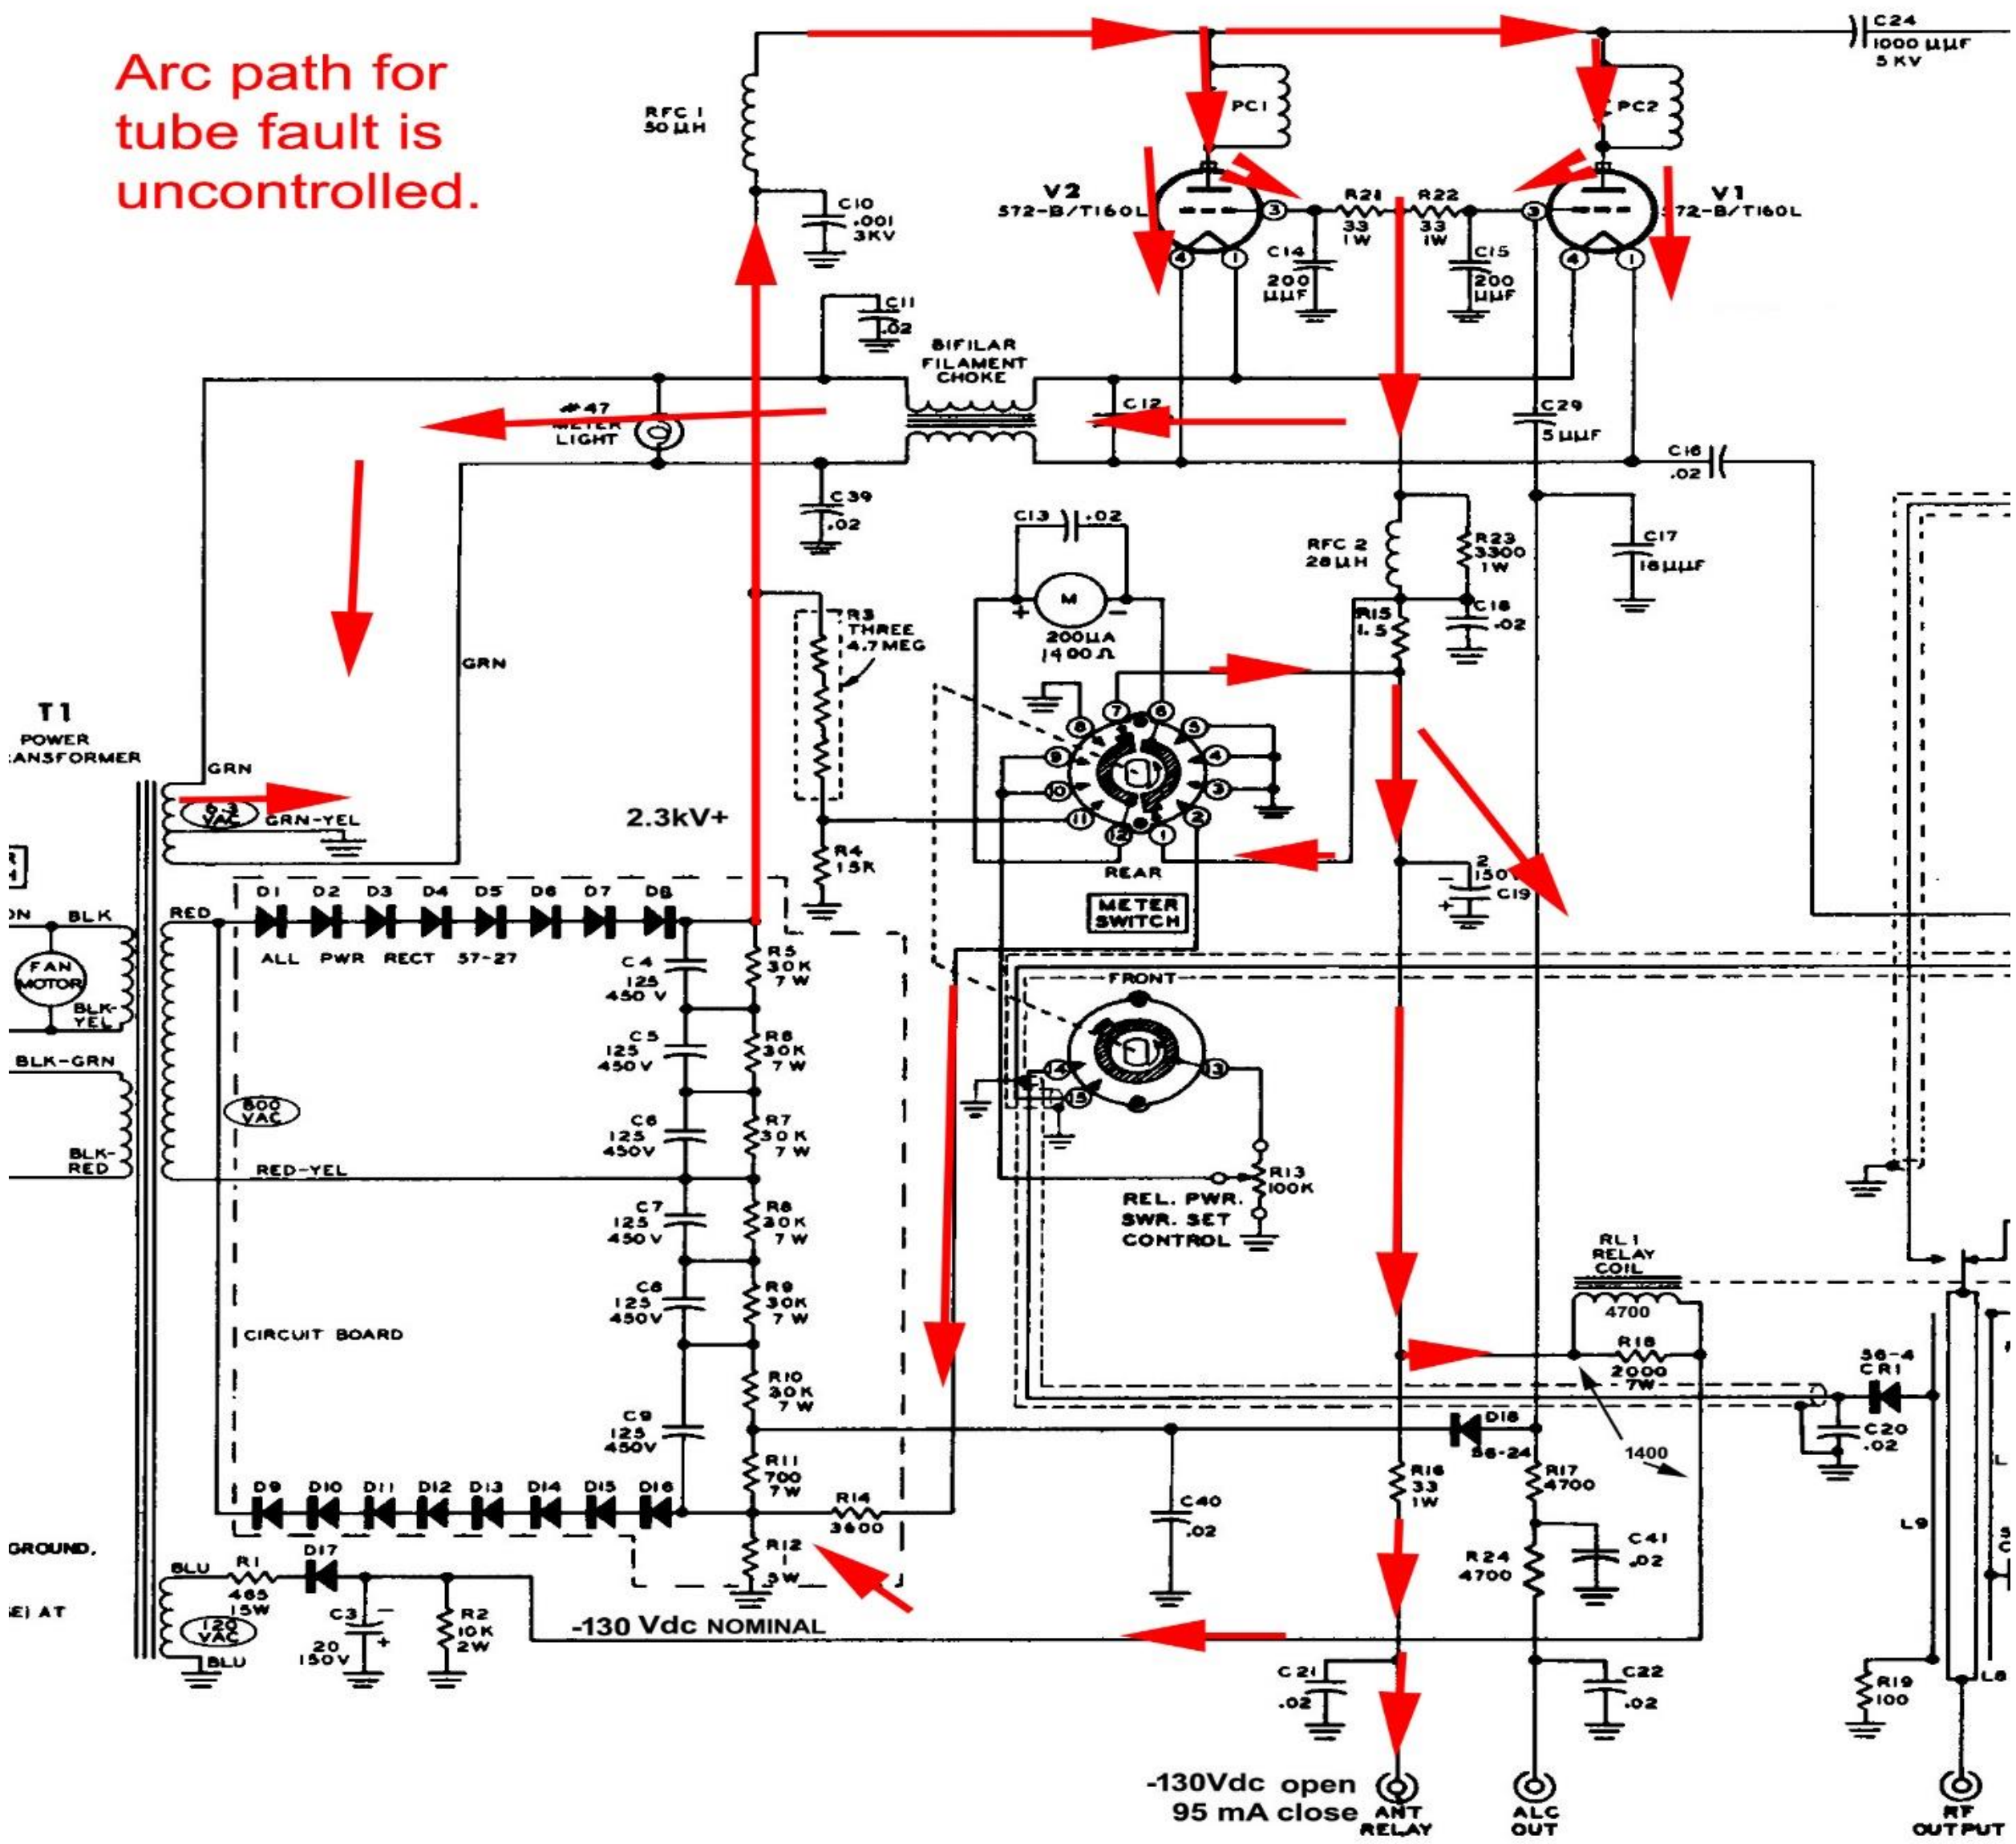
*Figure 1*

The original circuit and fault path is:

Tracing the fault path, we find common tube-anode to grid-and-filament faults have no defined path, instead scattering all through components. A significant percentage passes through the input network to the radio's RF connection, damaging radios at times.

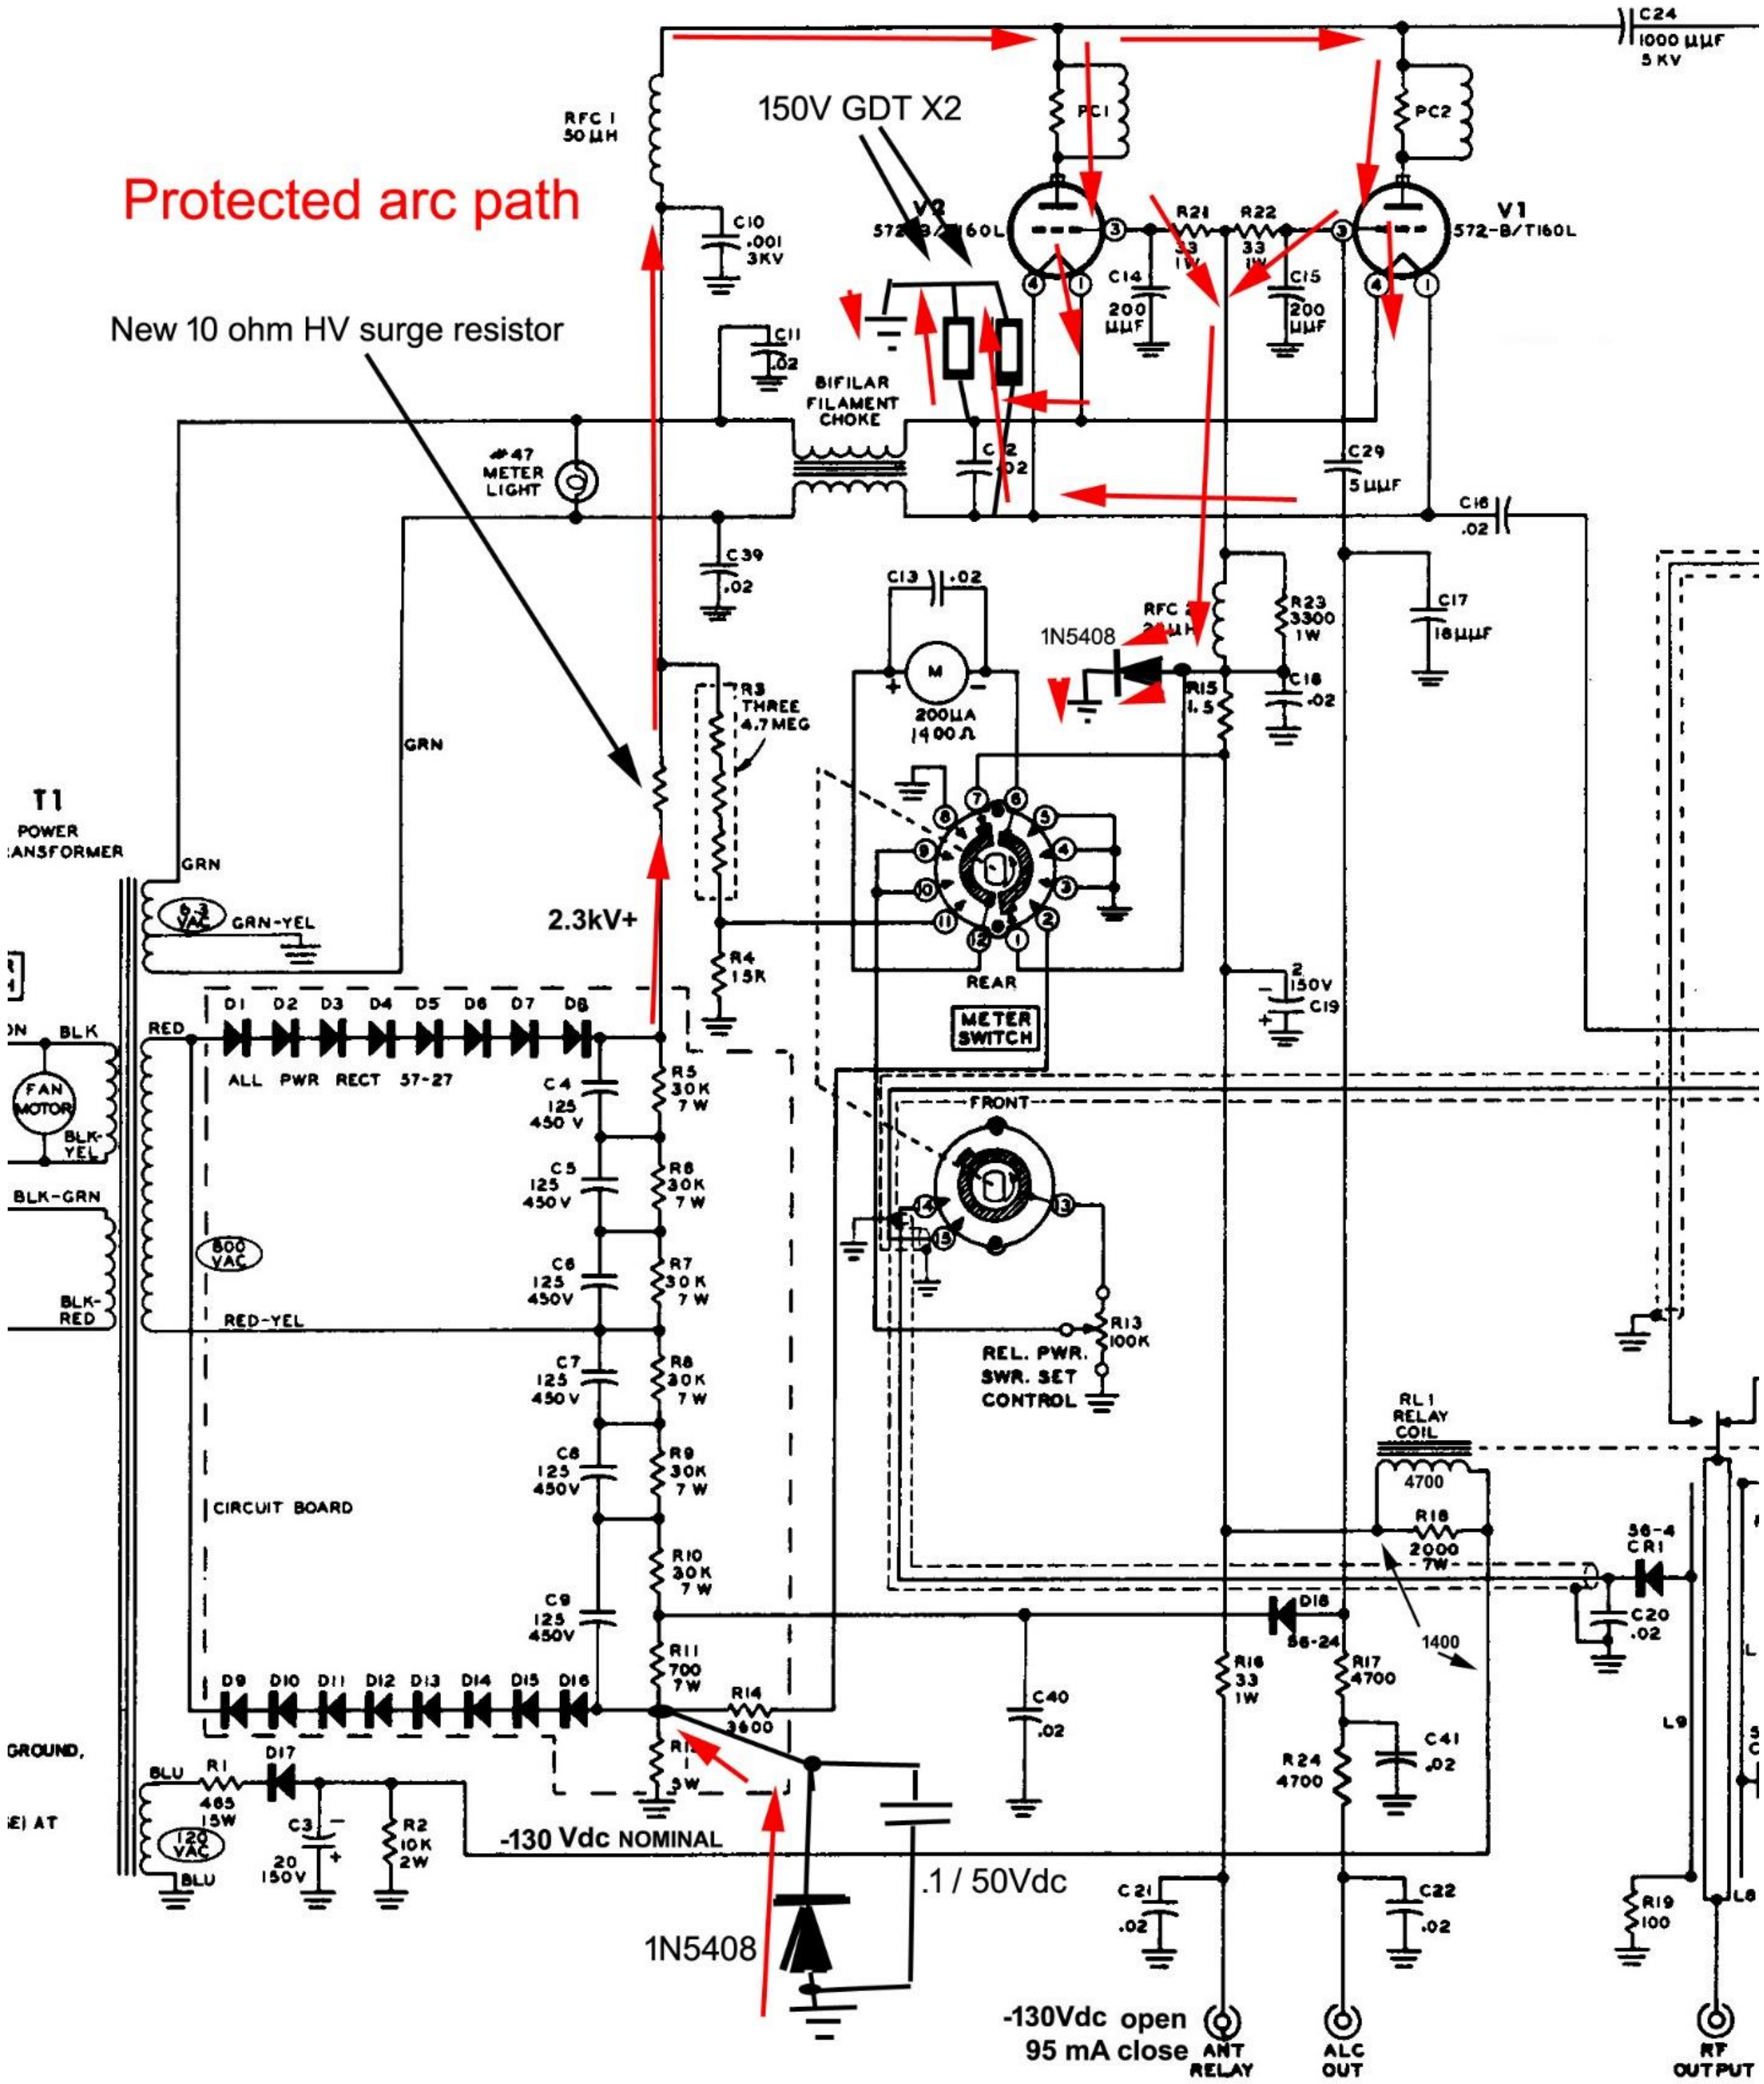
*Figure 2*

This modification adds a negative power supply rail clamp, grid bias clamp, filament clamps, and surge resistance. It controls and confines the fault path, keeping destructive currents away from expensive or largely irreplaceable components. Some chokes and small readily replaceable components do remain in the fault path. An additional 230V GDT from the grid pin group to the chassis helps significantly. Our tests have shown this to nearly eliminate tube short damage.
